CHINA CLASSIFICATION SOCIETY

**BULK CARRIERS - GUIDELINES FOR SURVEYS,  
ASSESSMENT AND REPAIR OF HULL  
STRUCTURES  
2014**

**Implementation date: July 1, 2014**

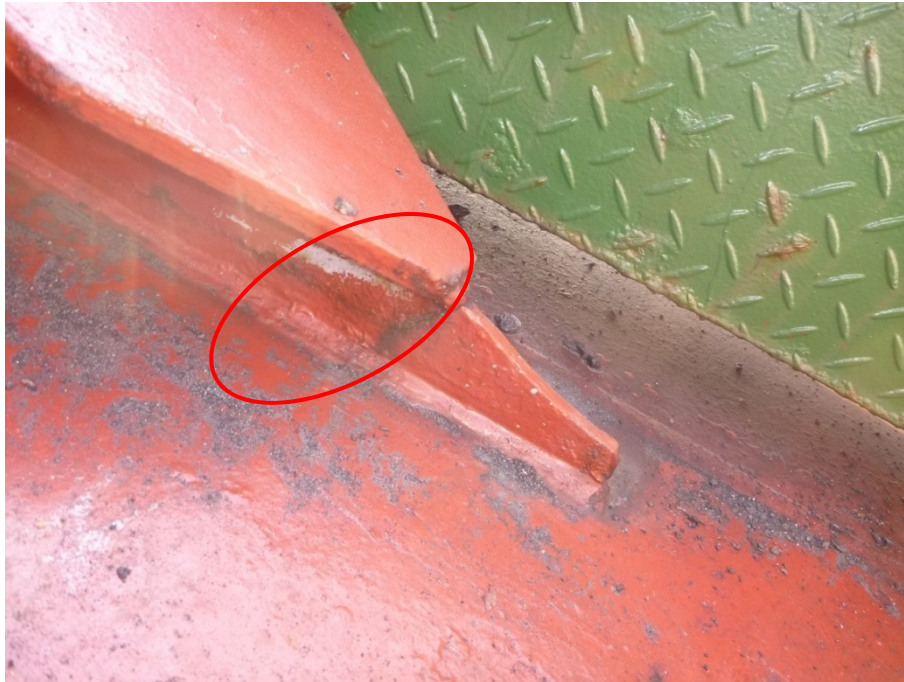
There is stress concentration at the toe end of bracket supporting the longitudinal hatch coaming. If the structure is designed in non-reasonable type for delivery of stress flow, the toe end is very easy to crack.

Figure 3.7.1.5 (4) Cracking in toe end of bracket

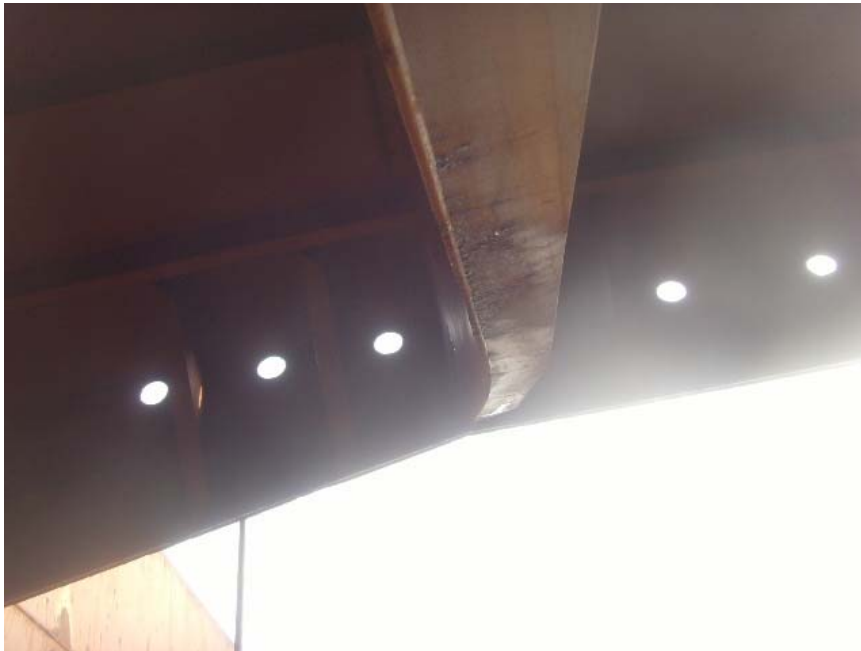
Figure3.7.2.5 Longitudinal large bracket deformation

- 3.7.2.5 Attention is to be paid on the large longitudinal braket's deformation under cross deck. Due to the lack of stiffener strength of large braket, which will result in buckling and deformation, large bulk carrier is always equipped with longitudinal brackets below the cross deck.

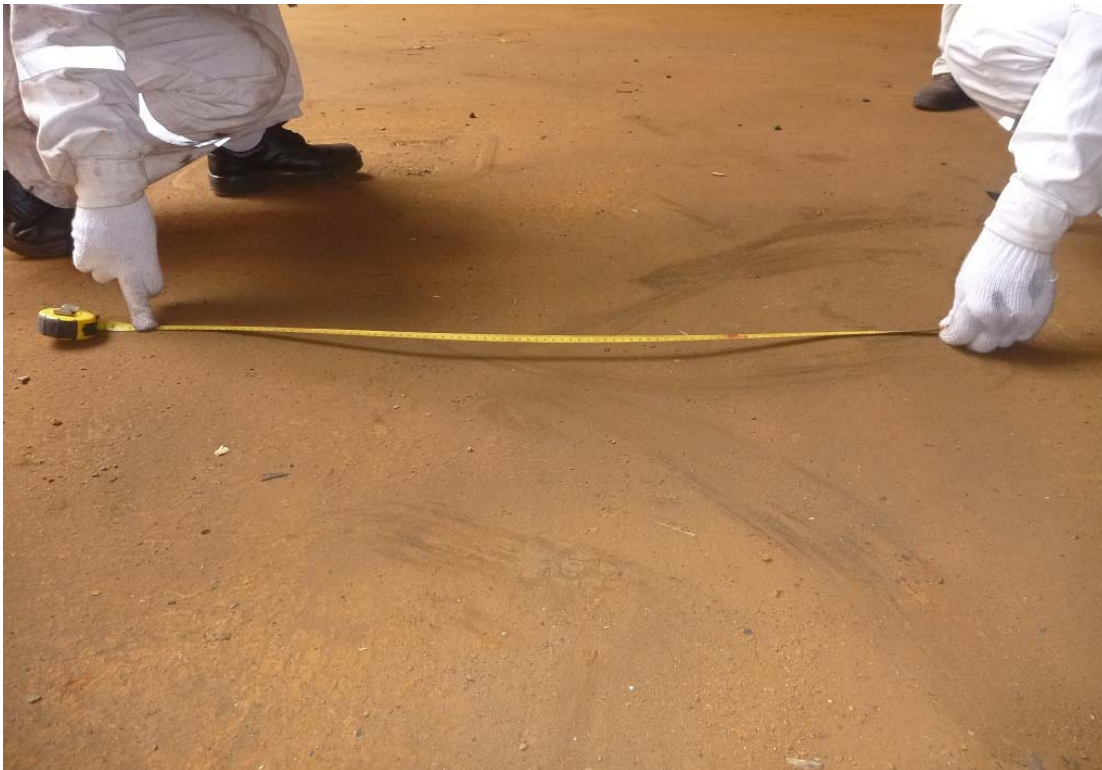
- 3.7.2.6 Inner bottom plate of cargo hold is liable to get collision and deformation by grab, etc.

Figure 3.7.2.6 Inner bottom deformation

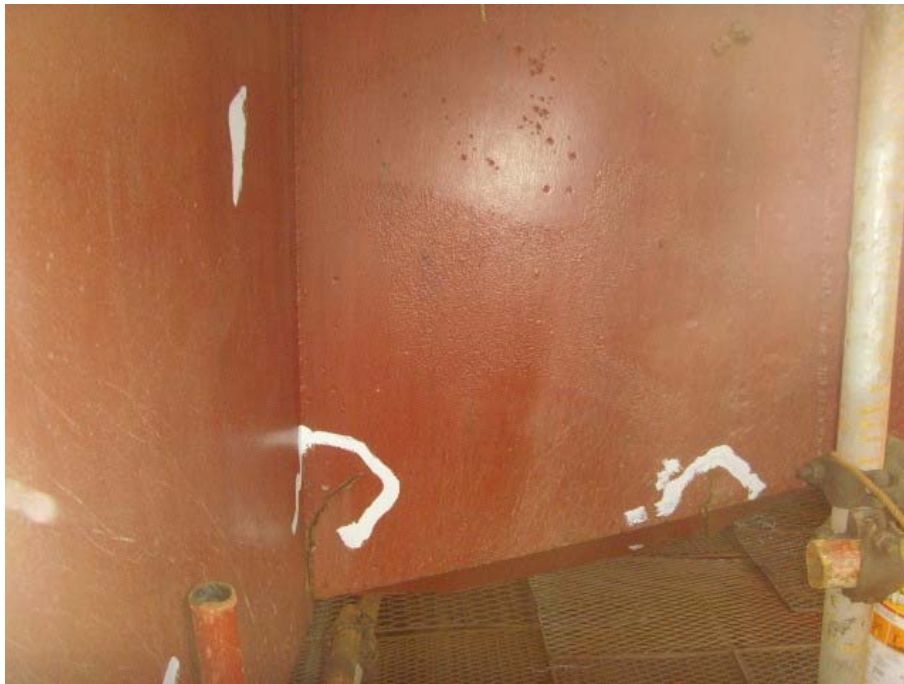
Figure 3.7.2.10 (2) Crack at beam toe end

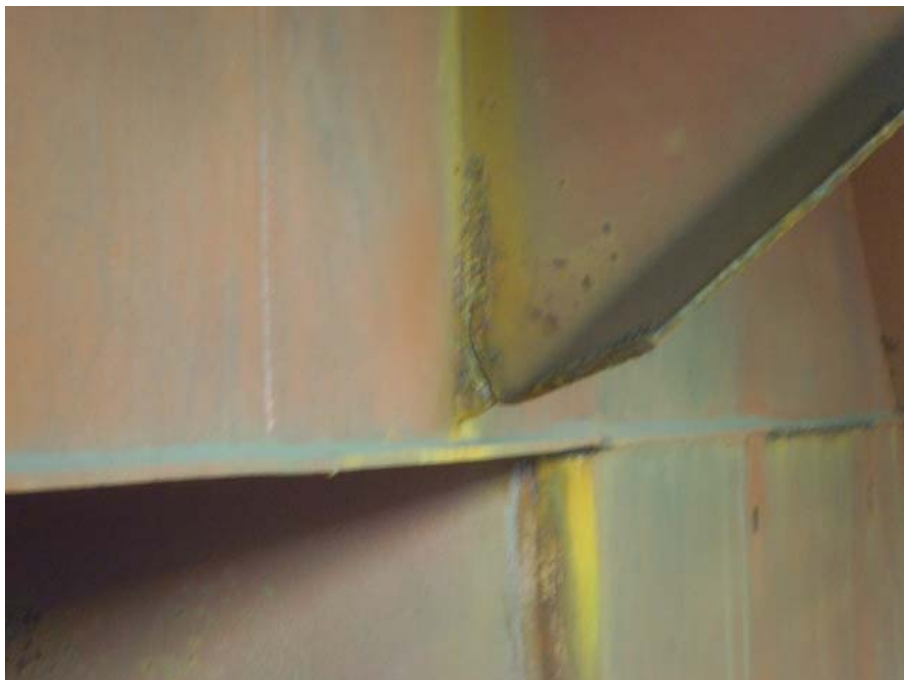
3.7.2.11 Attention is to be paid on the large longitudinal bracket's deformation under cross deck. Primary member toe end is easily to get stress concentrated and cracks. If a crane is installed in the cross deck, the toe end of bracket supporting longitudinal girder is liable to get crack.

Figure 3.7.2.11 (1) crack at toe end of Longitudinal bracket

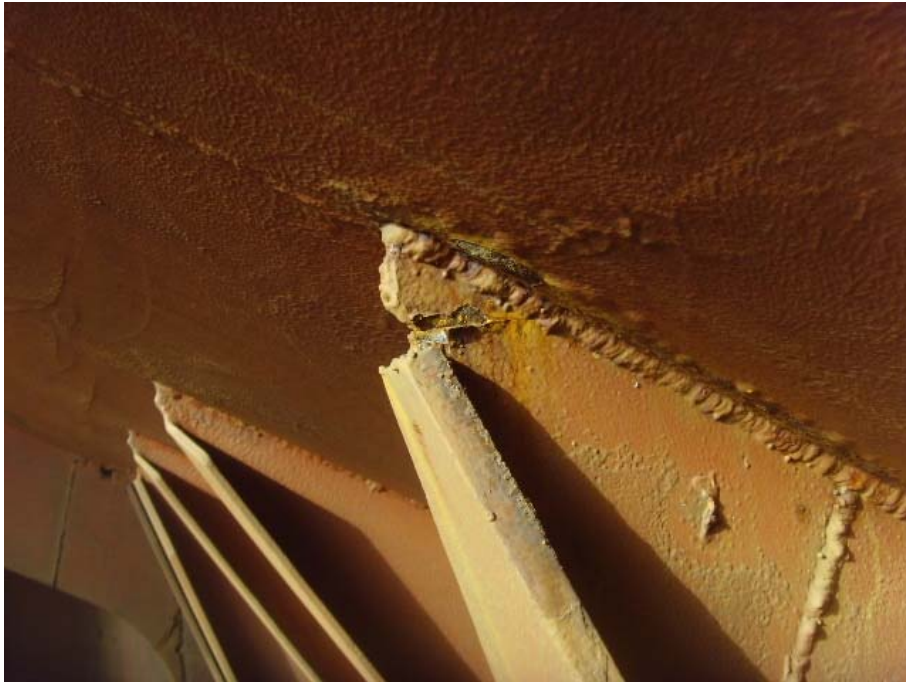
3.7.2.12 Attention is to be paid that the toe end of upper and lower bracket of shell frame is cracked, especially for the toe end of T-type shell frame.

Figure 3.7.2.12 (1) Crack at toe end of upper bracket

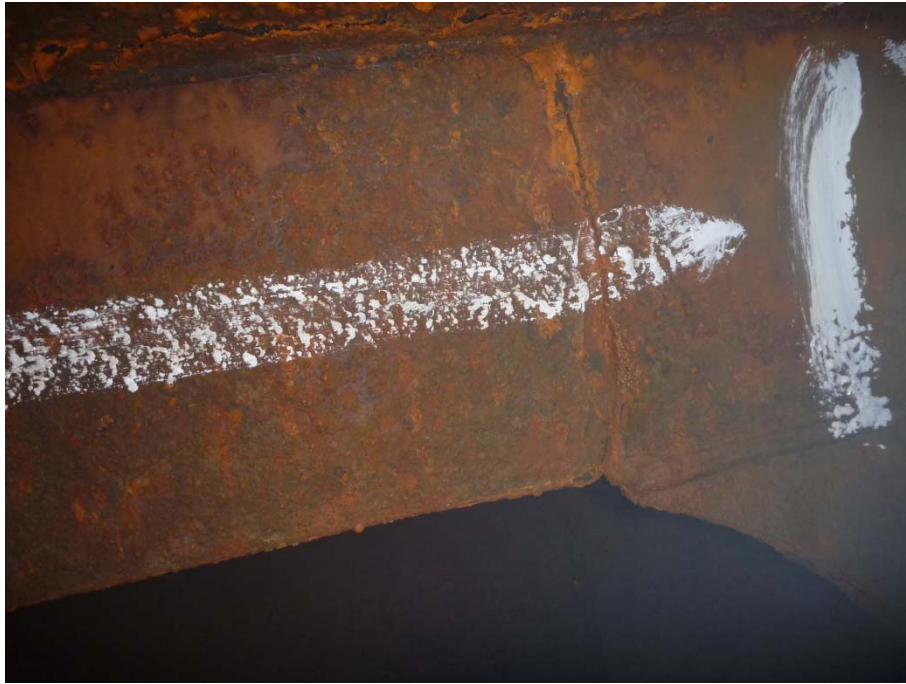
Figure 3.7.4.2 (2) Cracking in inner bottom Longitudinal

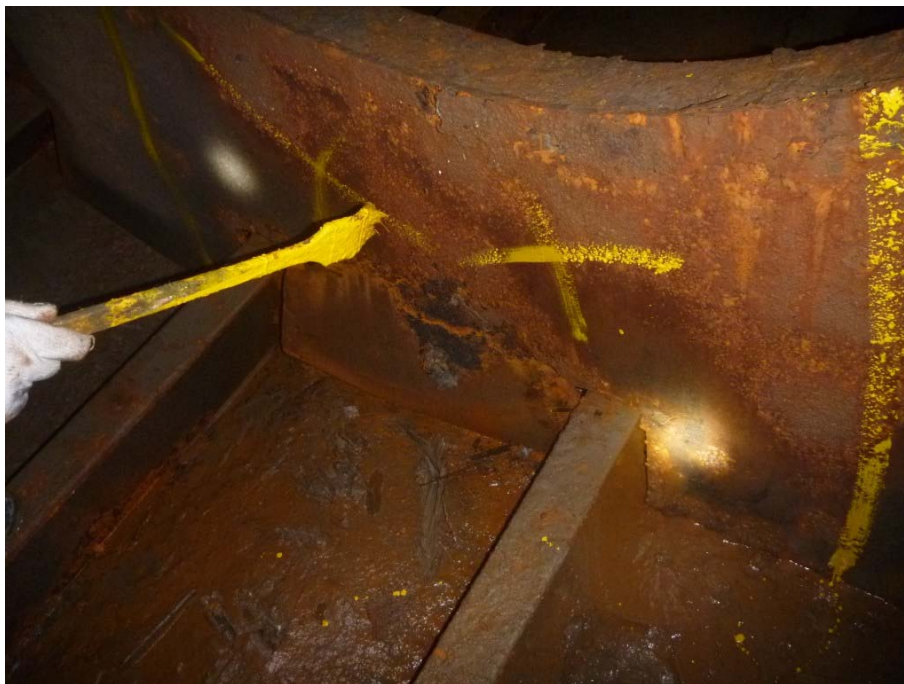
Figure 3.7.4.2 (5) Cracking at the Opening of Trans. Web

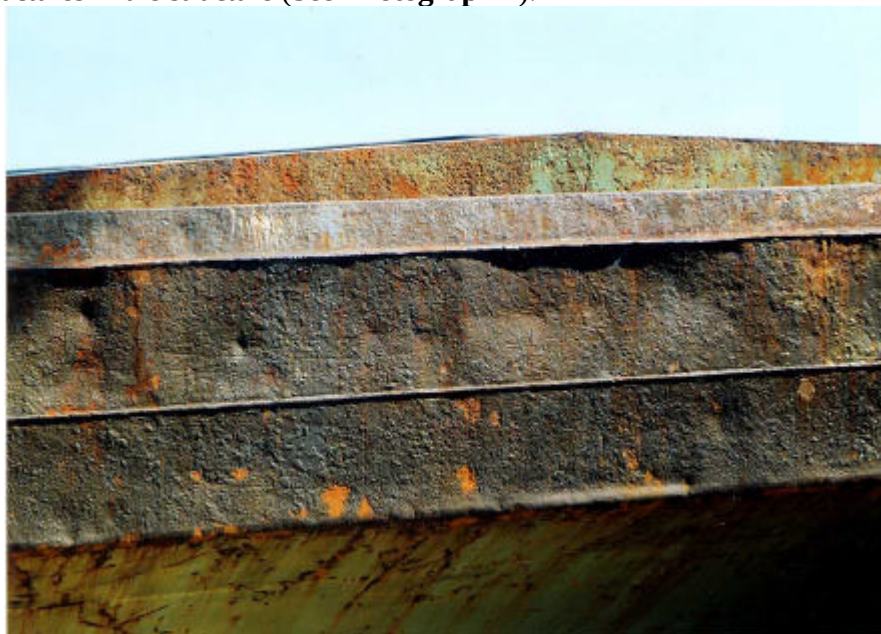
**Photograph 1**      **Heavy corrosion of hatch coaming and topside tank plating vertical strake**

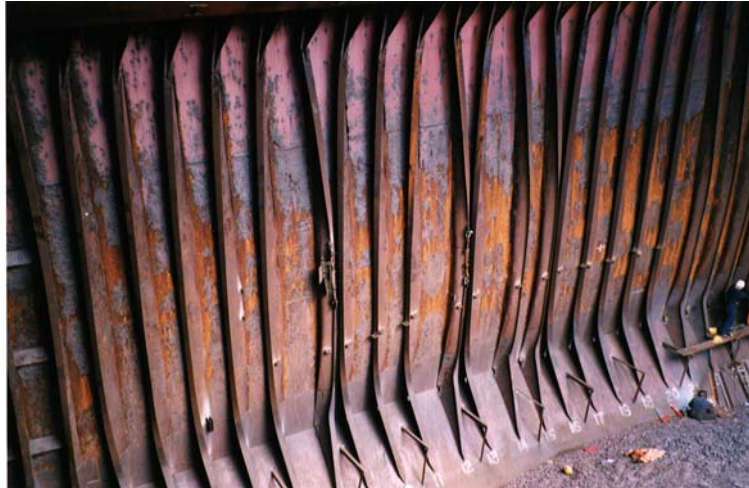
**Photograph 1** Collapsed side shell frames (See Example 4)

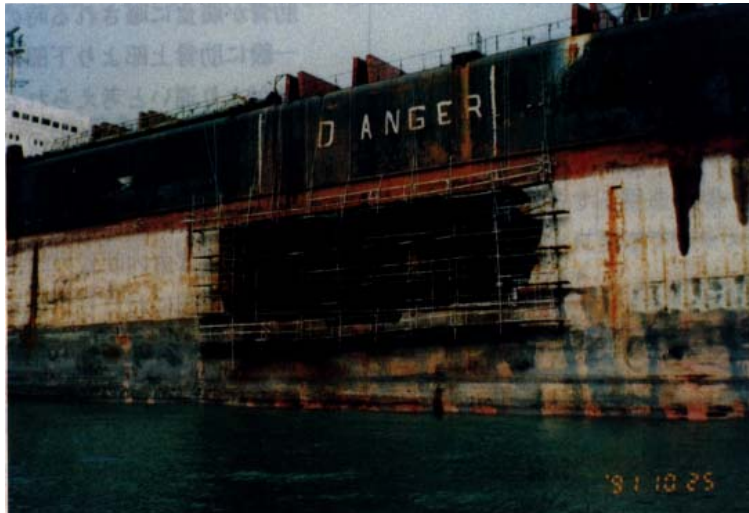
**Photograph 2** Missing side shell structure (See Examples 4 and 5)

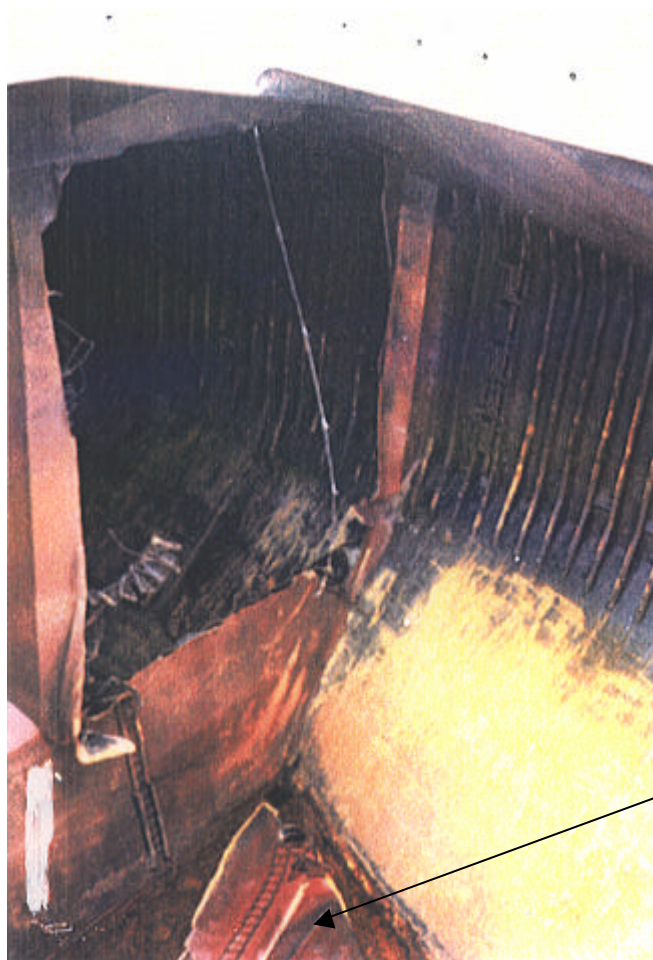
**Photograph 1**  
**Collapsed and detached**  
**transverse bulkhead**

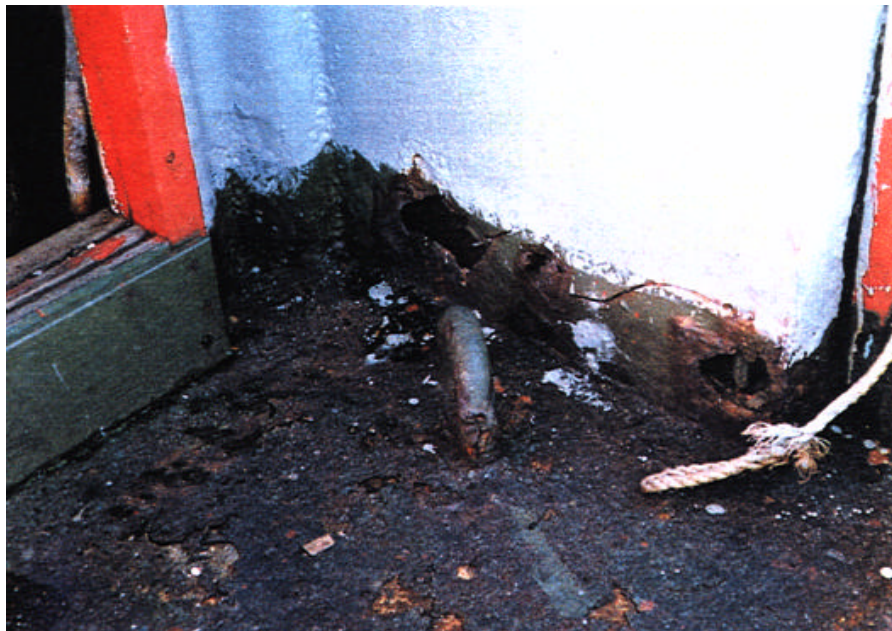
**Photograph 1     Corroded accommodation house side structure**
